## PILE RESTORATION AND PROTECTION

Carl W. Scheffel P.E.  
H. Michael Simpson

Fox Industries, Inc. 3100 Falls Cliff Road Baltimore, MD 21211; PH (410-243-8856);  
FAX (410-243-2701); email: [cscheffel@foxind.com](mailto:cscheffel@foxind.com)

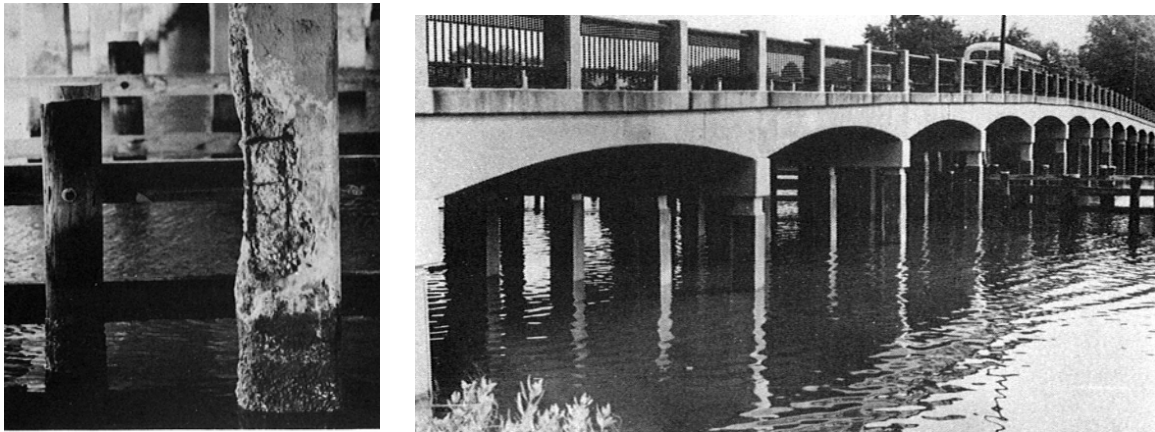
One of the first projects to utilize the fiberglass jacket and epoxy system was the 26<sup>th</sup> Street Bridge in Norfolk, VA. The original plans called for placing a square shaped jacket around the deteriorated square piles and filling the void with the moisture insensitive epoxy grout. However soon after the job began it was discovered that the section loss of the concrete piles was much greater than anticipated. This would greatly increase the amount of epoxy grout that would be required to fill these larger voids. The more epoxy, the more expensive the job would be. The city of Norfolk, VA worked with the company that developed the fiberglass jacket system to find an economical solution to this problem. The area had an abundance of river gravel. Testing was done to see how the epoxy grout would react when mixed with the river gravel. Test cubes were made and it was determined that the epoxy mixed with the river gravel would far exceed the minimum requirements of the design strength for the epoxy grout. The river gravel increased the yield of the epoxy to the extent that the project was able to come in on time and on budget.

Figure 5: The first image shows a severely deteriorated pile at the 26<sup>th</sup> Street Bridge, the second shows the completed restoration, 106 piles in total

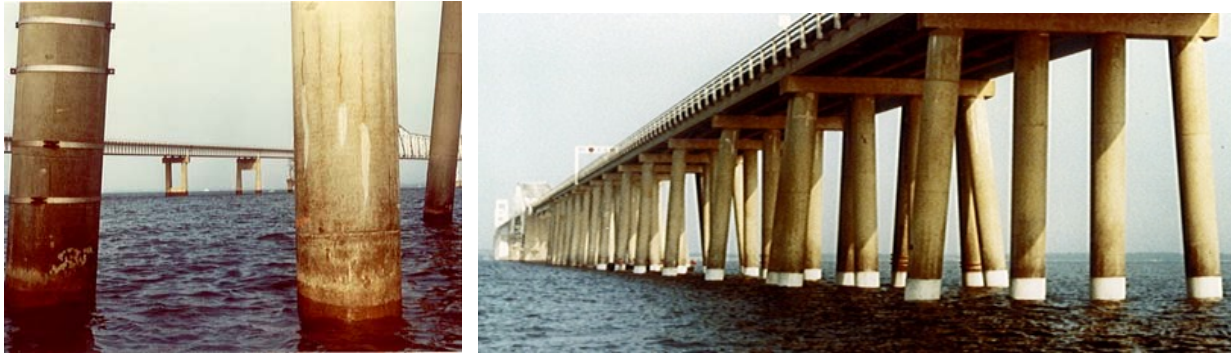
In the early 1980's the fiberglass jacket system was utilized to repair and protect over 300 Raymond Hollow Piles on the Chesapeake Bay Bridge in Maryland. The piles measured 54" diameter. The piles were exhibiting deterioration in the form of cracks that would allow moisture and salt to penetrate the piles. The structure was located in a region that sees temperature ranges from 0°F to 100°F. If left untreated this could cause structural damage to the piles that would eventually endanger the structure. Based on testing conducted by the Maryland State Roads Commission in the 1970's, and successful use of the fiberglass system on other structures, a contract was let to place the system on more than 300 piles. The jackets were placed in the splash zone where the wetting and drying cycles and freeze thaw cycles were concentrated. The jackets were 55" in diameter x 1/8" thick x 8' long. The 1/2" annular void was filled with the moisture insensitive epoxy grout without dewatering. An inspection 20 years later found that the jackets were performing like the day they were placed.

Figure 6: Piles under the Chesapeake Bay Bridge showed extensive scouring due to conditions (Left). On the right, you can see the Bridge after the restoration has been completed.

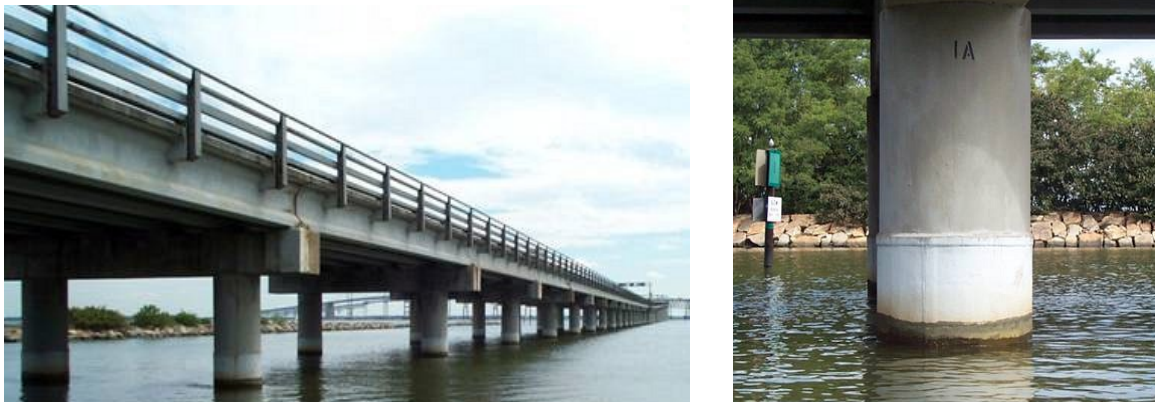
Figure 7: The Chesapeake Bay Bridge, pictured 20 years later. The piles restoration still looks as good as the day it was completed.

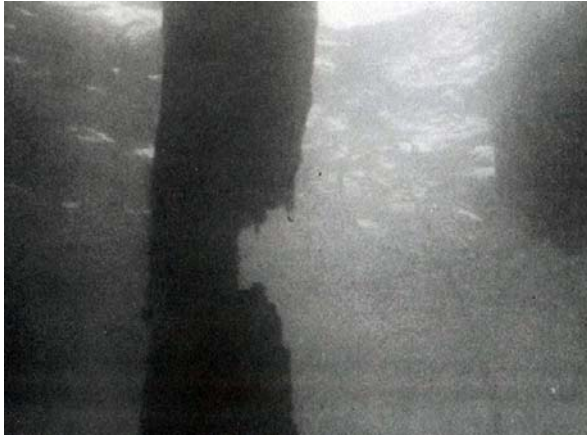
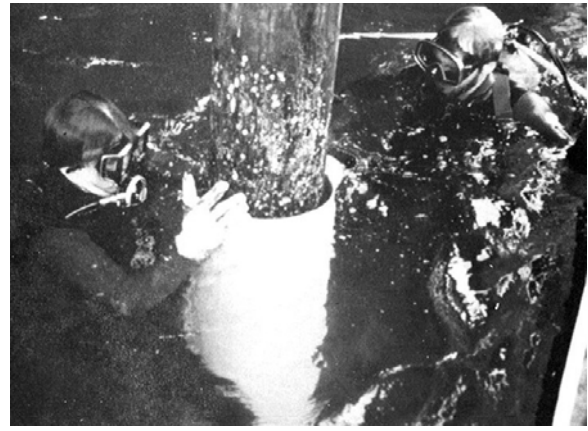
In the late 1970's, following the implementation of the Clean Water Act of 1972, it was determined that as the harbor waters were cleaned up, they became a breeding ground for marine borers, which are a great threat to timber piles supporting bridges and piers. The marine borers would burrow their way deep into the woodpiles to the point that the piles would become structurally unsound. Again testing was performed on timber pile sections to determine the effectiveness of the jacket system. The epoxy grout easily penetrated the boreholes and tunnels and filled them while filling the annular void between the jackets and the piles. Over the past 30 years, thousands of woodpiles have been repaired utilizing the fiberglass jacket system.

Figure 8: Pictures of an early timber pile repair project.

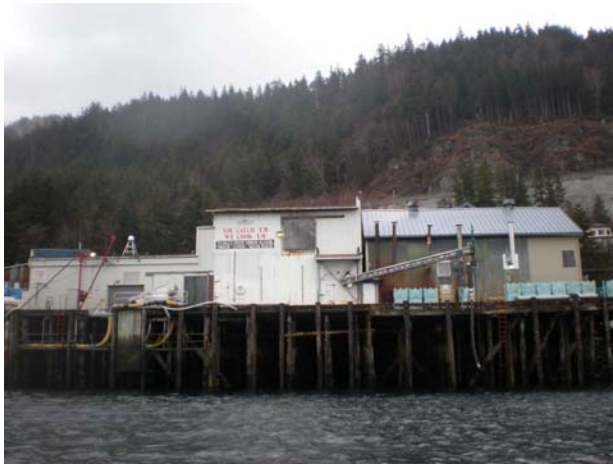
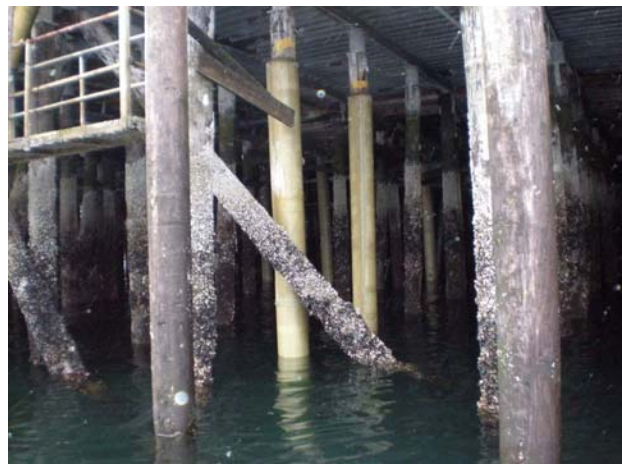
Figure 9: Ketchikan, AK – a Trident Seafood processing facility sites on a timber pile structure. Severe deterioration of the piling was threatening the facility. Restoration was completed with the fiberglass jacket system without needing a plant shutdown.

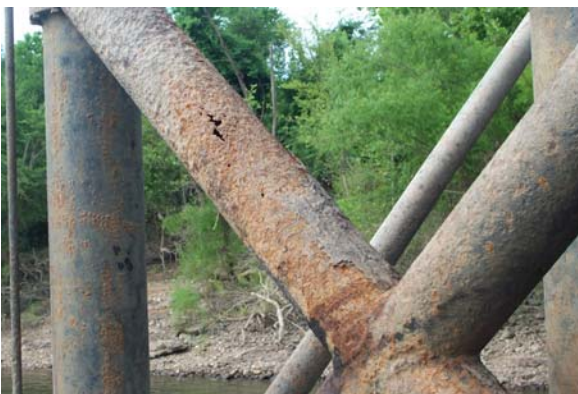
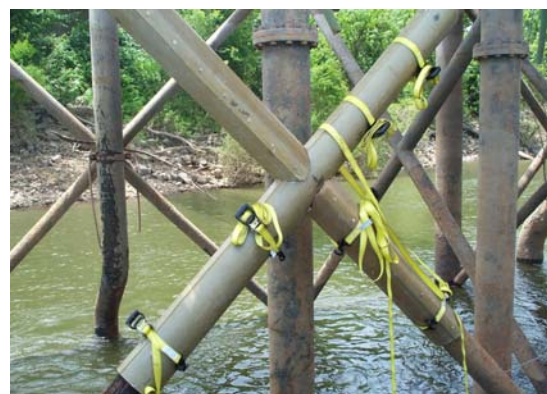
Many bridges are constructed with steel pipe and steel H piles. Steel will deteriorate differently from concrete or wood. Corrosion of the steel, the most common type of deterioration, may be caused by wetting and drying cycles; chemical attack; and exposure to the atmosphere.

Figure 10: Inland Steel Water Intake System before and after being restored with fiberglass jackets.

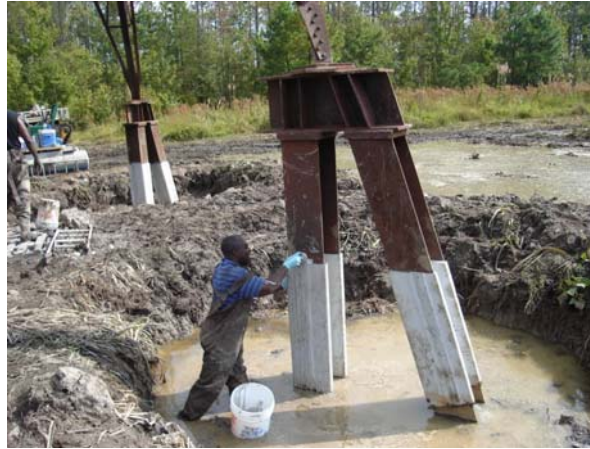
Figure 11: Steel H Piles repaired with an H-shaped fiberglass jacket.

Steel H piles may be repaired in several ways. Fiberglass jackets can be fabricated in the shape of the H pile. This type of jacket will be made in two pieces to facilitate ease of placement around the H pile. The standard void between the steel H pile and the H shaped fiberglass jacket will be  $\frac{3}{4}$ " minimum due to variances during the fabrication of steel H piles resulting in final dimensions that are not always exact. This void is filled with the moisture insensitive epoxy grout.

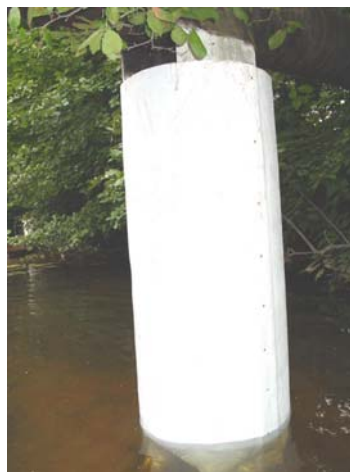
Figure 12: Steel H Pile repaired using a round fiberglass jacket.

Another method of repairing steel H piles with fiberglass jackets is to place a round fiberglass jacket around the steel H pile and fill the void with epoxy grout 6" in the bottom and 4" in the top. This leaves the majority of the void to be filled with a more economical, specially formulated, cement based grout that can be pumped or poured into the void without dewatering. By encapsulating the special cement, grout with epoxy the cement grout is protected from moisture and air.

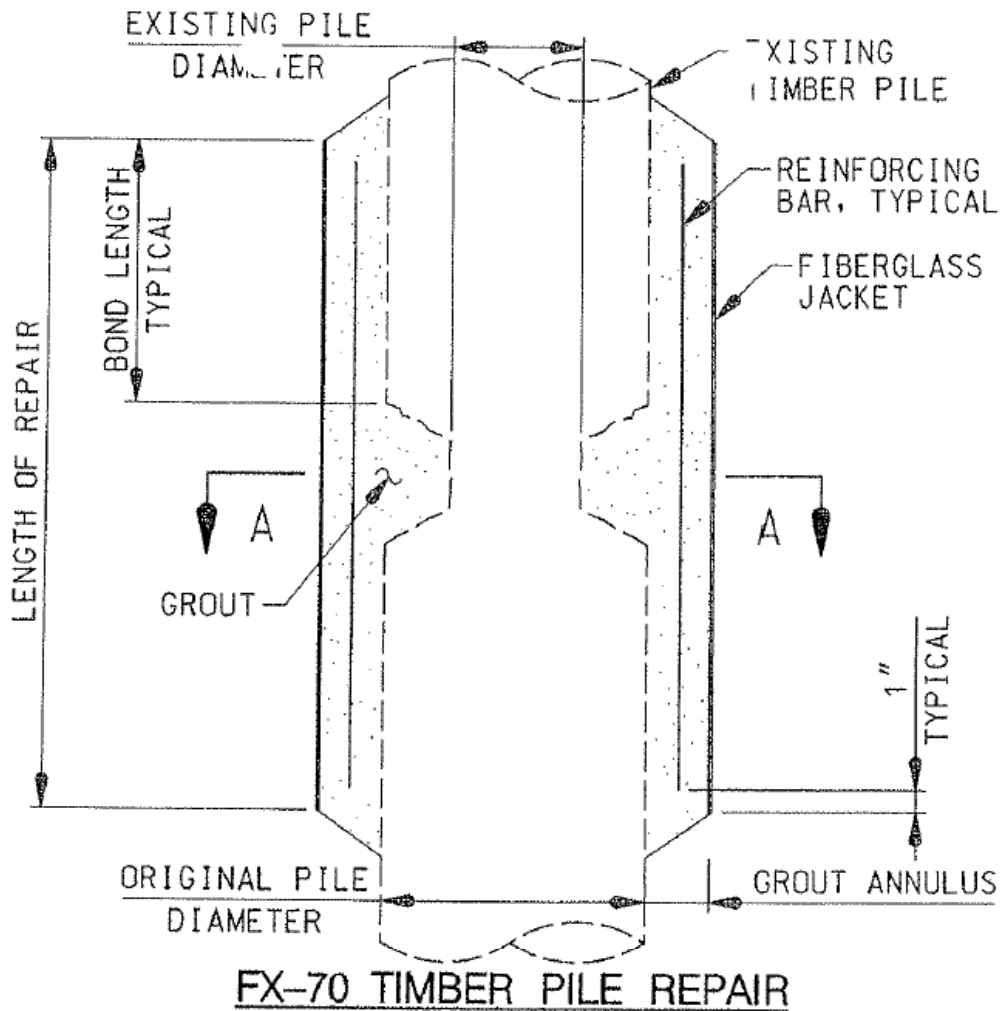
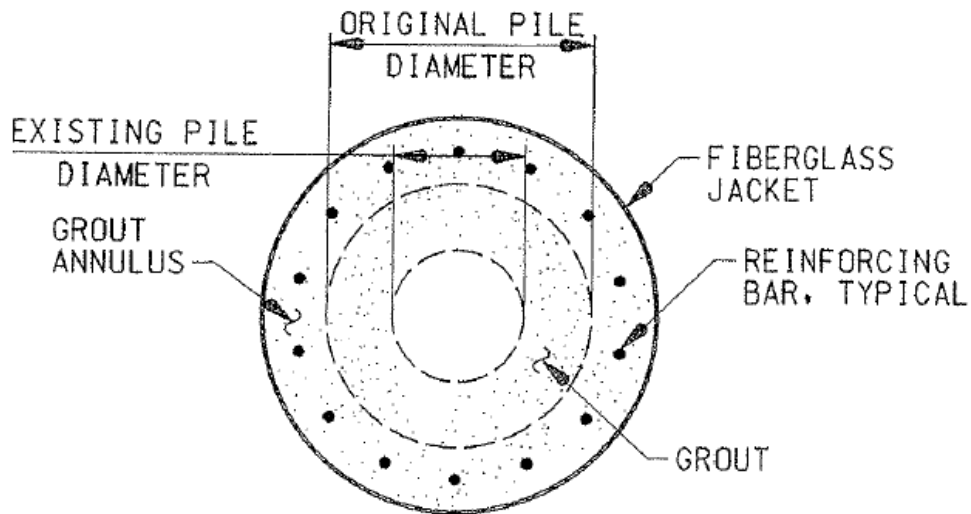
**FIGURE 1**

The Fox Industries FX-70 Timber Pile repair system consists of an oversized, interlocking fiberglass jacket that is wrapped around the damaged portion of an in-situ timber pile. Once the jacket is in place, a filler material, consisting of either epoxy or cementitious grout, is pumped in the void between the remaining portion of the timber pile and the fiberglass jacket. Steel reinforcing bars can also be added in this void. The geometric layout of the repair system is shown in Figure 1, attached.

The critical bond length required to develop the original flexural capacity of the pile was determined to be at the interface of the timber pile and the grout, due to a combination of the high stresses at this interface and the fact that the shear strength of the wood is substantially less than that of the fiberglass jacket and the grout, therefore controlling the overall bond strength. For full strength development, the repair should extend at least 18" above and below the damaged timber pile area.

For the pile size utilized for this study, the jacket bond length should extend a minimum of 18" above and below the area of repair.
