**Public Service Electric and Gas  
of New Jersey Selects Fox Industries, Inc.'s  
FX-70® System to Restore H-pile Supports**

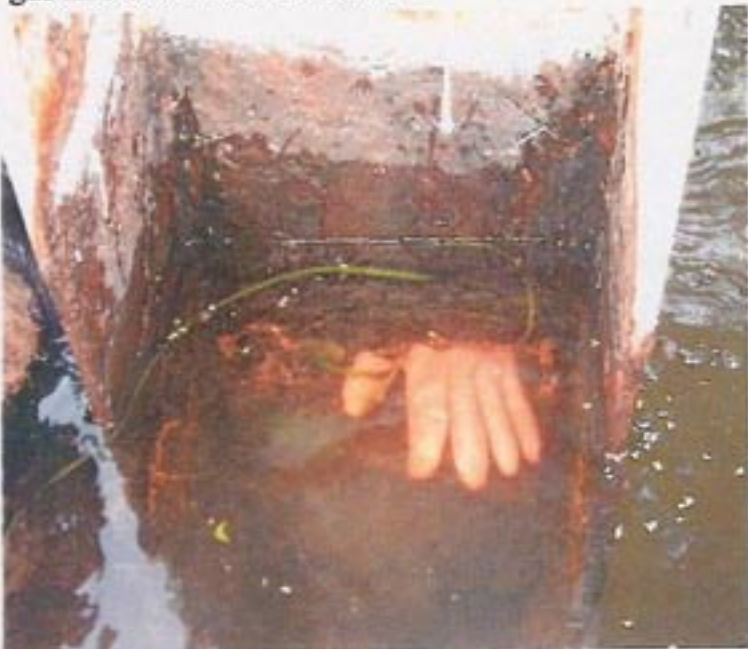
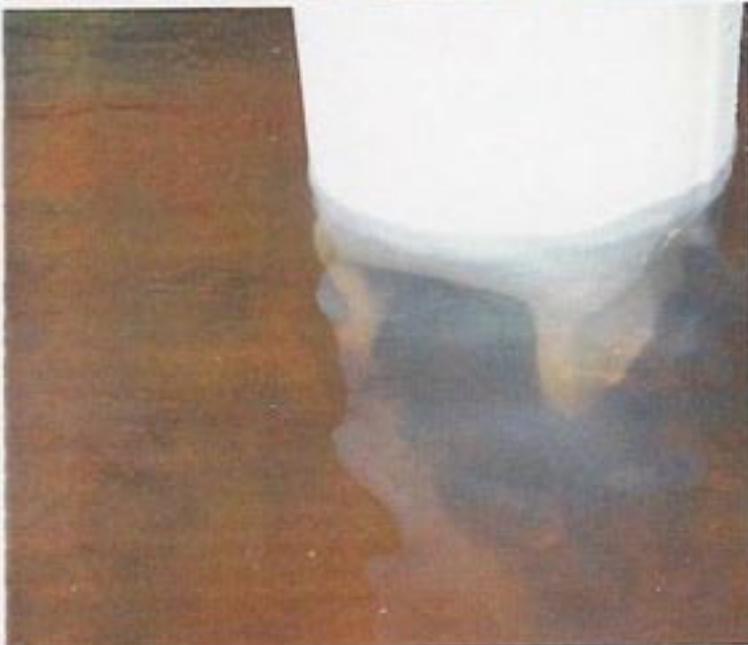
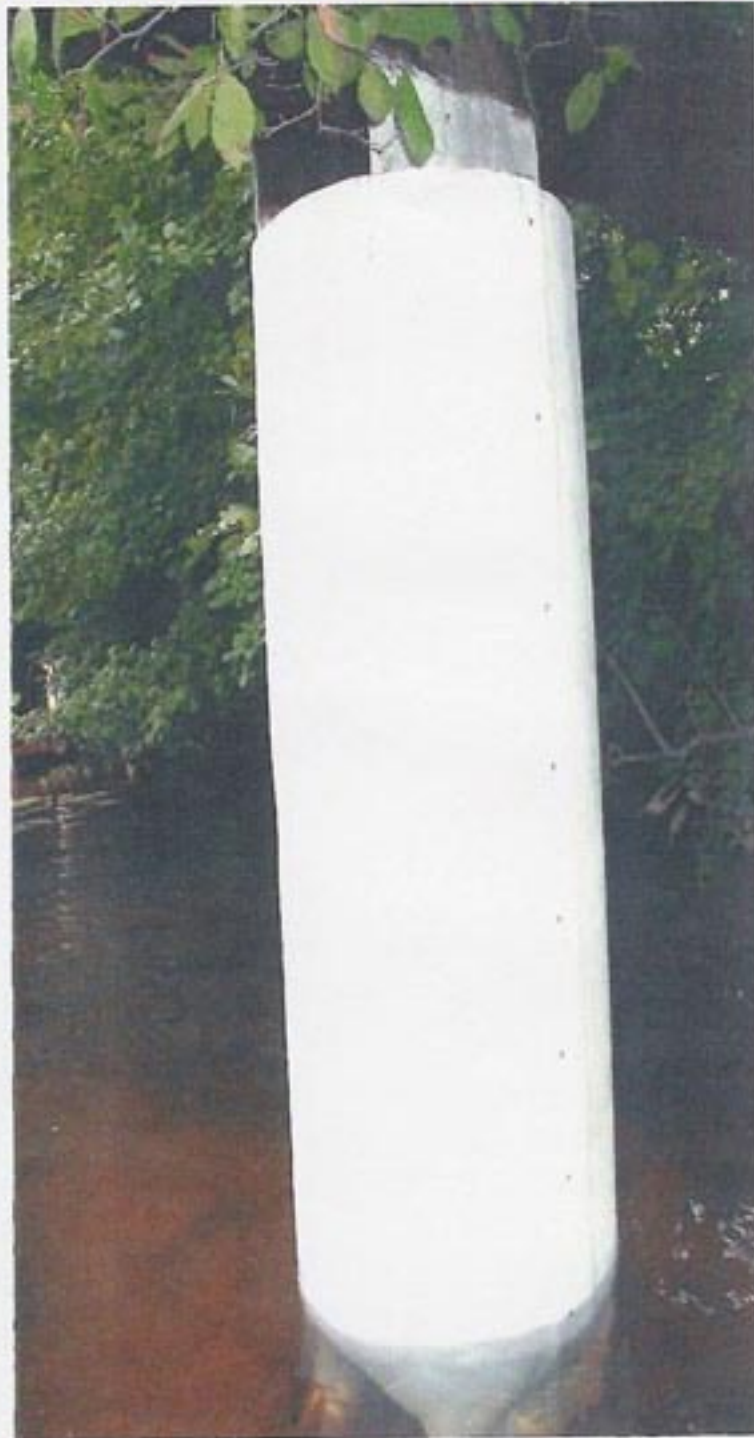
**Problem:** Wet and dry cycles deteriorated steel causing severe section loss in 14x73 HP supporting gas line over the D&R canal.

**Solution:** The deteriorated section of H-pile was bridged using steel channel. Structurally restored pile is permanently protected with FX-70® Inert Corrosion Free System without any disruption in service. The FX-70 System consists of a stay-in-place FRP jacket, a bottom seal of FX-70-6 Pourable Epoxy Grout, and filled with FX-70-8® Underwater Mortar.
